# Manhole Inspection Summary

Manhole # **S33C\_\_057MH**

Insp Date: **10/11/07 2:58 PM**

**Location** Address: **409 TYSON ST** Cross Street: **MULBERRY ST**

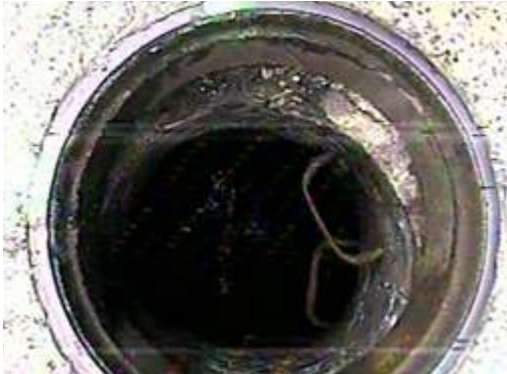
Top View

**Frame** Offset: **3** (in.) Condition: ☒ Sound ☐ Cracked ☐ Leaks

FRAME OFFSET

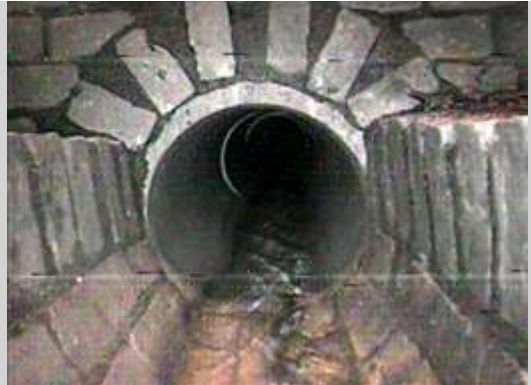
12 O'Clock Outflow

10 in. Circular Gravity Sewer  
Pipe Out @ 12 O'Clock

Pipe Height: **6** (in.) Rod and Bar  
Pipe Material: **Clay** ☐ Pipe Lined  
Invert Depth: **10.66** (ft.) Flow Characteristics: **Fast**  
Deposits: ☒ None ☐ Mud ☐ Sludge ☐ Debris ☐ Grease  
Silt Depth: (in.) Deposits Extent:  
Infiltration: **None** Pipe Seal Cond: **Sound**

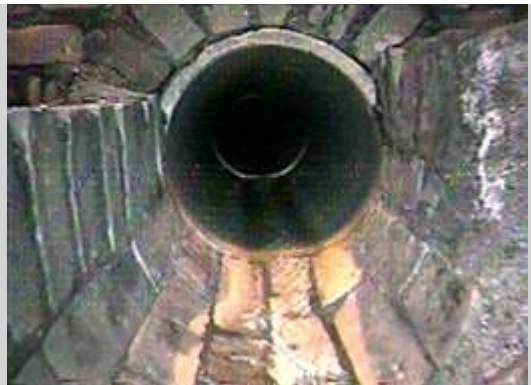
6 O'Clock Inflow

10 in. Circular Gravity Sewer  
Pipe In @ 6 O'Clock

Pipe Height: (in.) Direct  
Pipe Material: **Clay** ☐ Pipe Lined  
Invert Depth: **10.70** (ft.) Flow Characteristics: **Fast**  
Deposits: ☒ None ☐ Mud ☐ Sludge ☐ Debris ☐ Grease  
Silt Depth: (in.) Deposits Extent:  
Infiltration: **None** Pipe Seal Cond: **Sound**

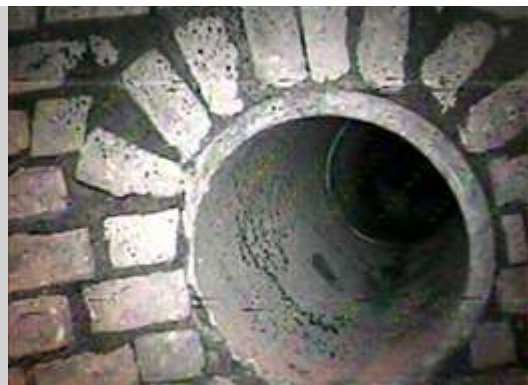
9 O'Clock Inflow

10 in. Circular Gravity Sewer  
Pipe In @ 9 O'Clock

Invert Depth: **9.83** (ft.) Flow Characteristics: **Slow**

Infiltration: **None** Pipe Seal Cond: **Sound**

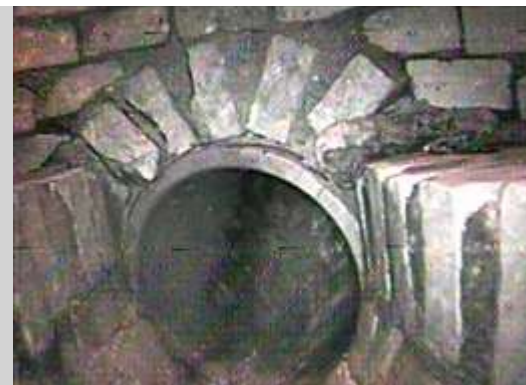
Drop In @ 9 O'Clock

Drop: **Outside** **Direct**

Inv Depth: **10.69** (ft.)

Drop Condition: **Open**
